PowerForce Helix 2111F

Blowing Dust

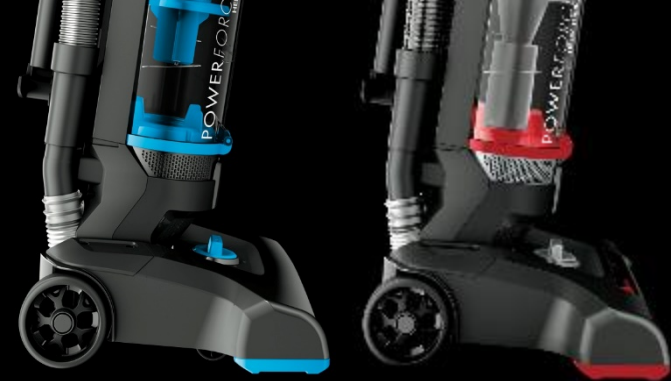
- Is the hose properly secured in the back of the unit?

If:	Then:
No	    <ul style="list-style-type: none">• If hose is not properly secured, have the consumer connect the hose into place in the back of the unit. If the end of the hose is cracked <p>BISSELL Consumer Care: please refer to the product changeover guide.</p> <p>External Support: Contact BISSELL.</p>

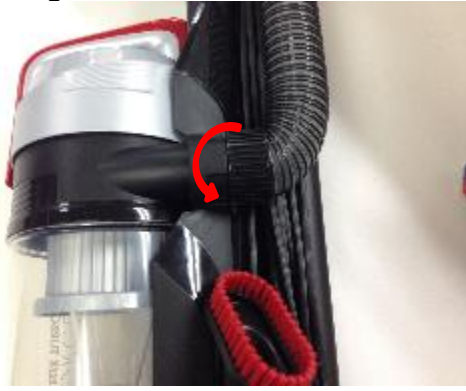
If:	Then:
<p>To Check:</p>	<p>Remove the hose where it attaches to the back of the vacuum by twisting $\frac{1}{4}$ turn to the left.</p>

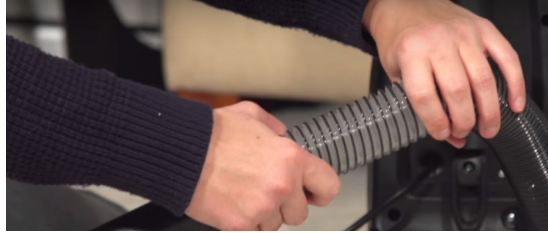
<p>Check the entire length of the hose for any holes, cracks, or damage and replace if needed.</p>

<p>Also inspect the lower hose for holes, cracks, or damage</p>

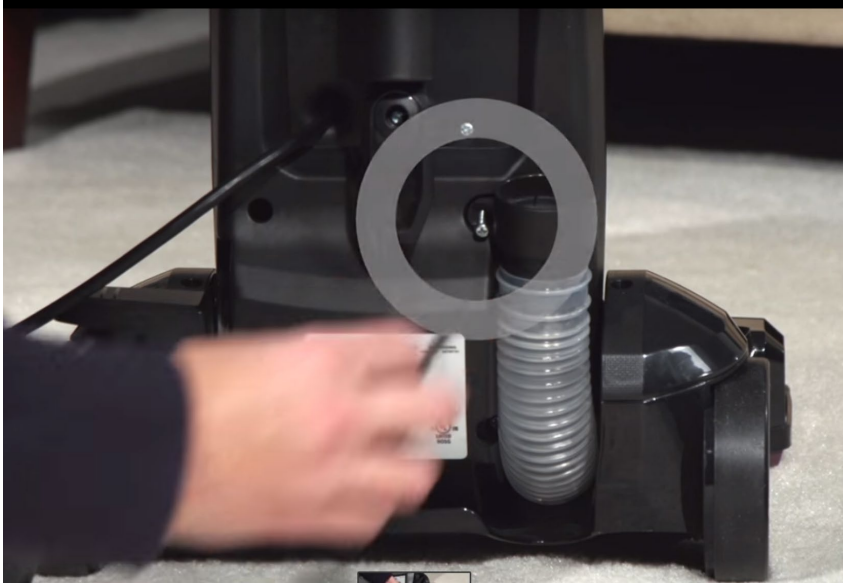
If:	Then:
<p>To check:</p>	<p>Unplug the vacuum and remove the screw on the lower back of the machine holding the lower hose in place.</p>

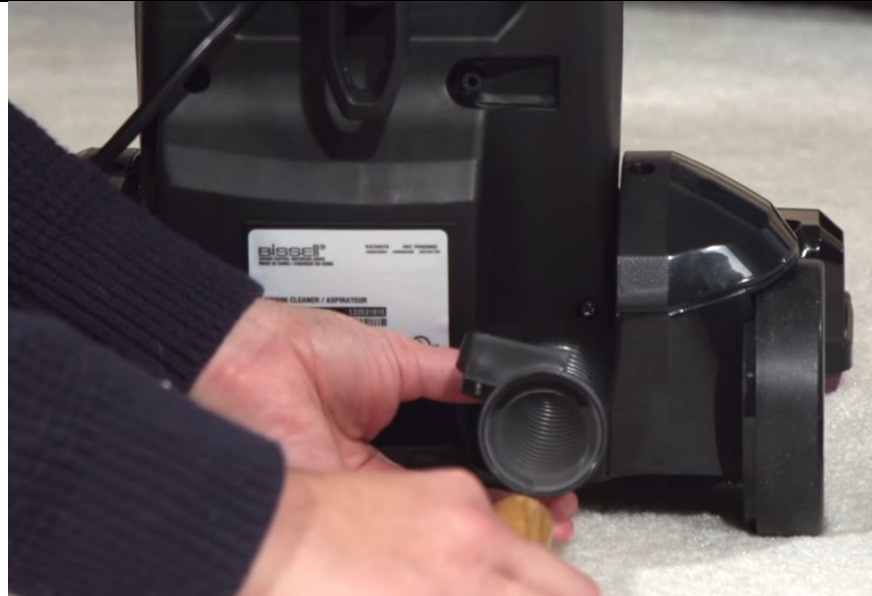
<p>Pull the lower hose flat to the ground</p>

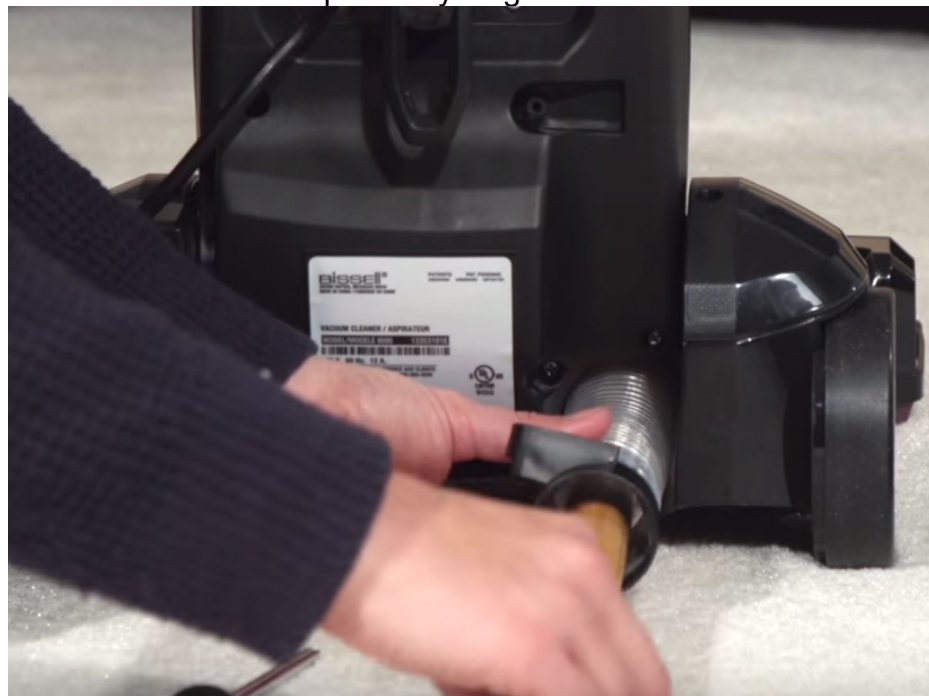
Insert a broomstick to push any clogs thru.
